CORROSION TECHNICAL BULLETIN

MAY 2016 | Revision 5

Immersion

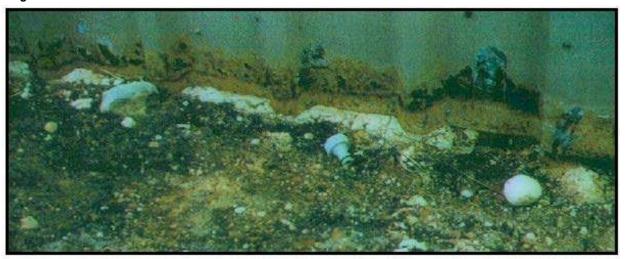
Figure 1: Immersed Shed Wall

BlueScope therefore regard any construction practice which intentionally utilises ZINCALUME® steel based product for concrete form-work, such as in the case of garage/shed walling to retain concrete floors or external pathways which are post poured, as sub-standard building practice.

Therefore the recommended BlueScope product for use with uncured concrete and highly alkaline bonding material is galvanised steel.
