## Common Quality Issues That Are Not Linked To BlueScope's Coated Steel Material

This Fact Sheet serves as a reference on commonly observed quality issues or defects that are not related with the performance of BlueScope's coated steel material.

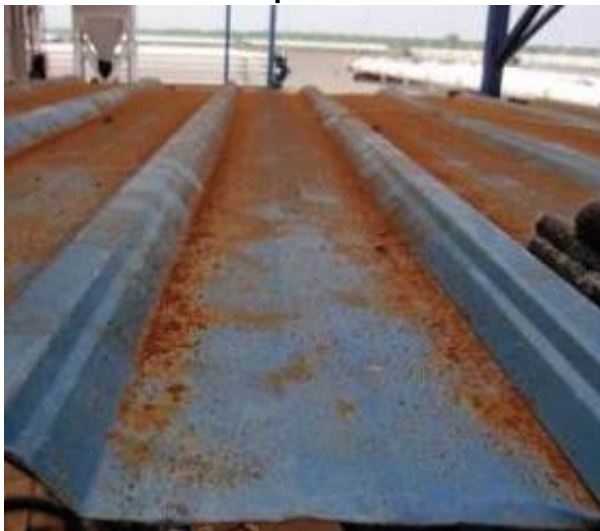
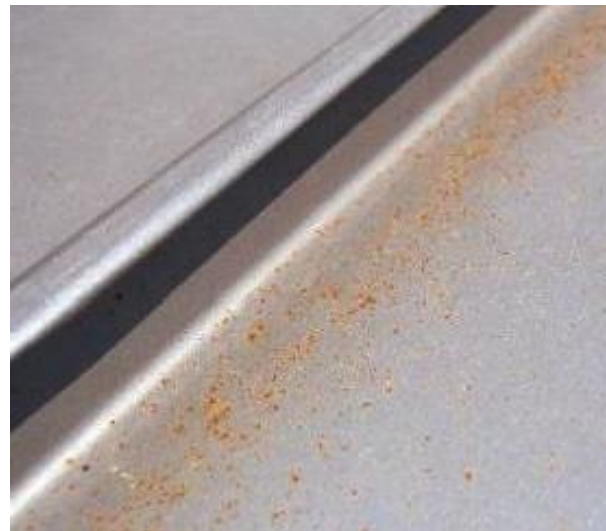
#### 1. Contact with swarf particles

This is one of the most common signs of rust which is wrongly attributed to the failure of a coated steel, which we call "swarf stains". Swarf refers to steel debris arising from abrasive cutting using friction saws, and abrasive disks of steel products. The swarf particles will not be immediately noticeable but, if left on the surface for days, the particles will start rusting leading to the examples shown in the above photos. These stains are too often mistaken as the rusting of the roofing sheets.

To remove the swarf particles or rectify any damage caused by the swarf particles, you may refer to BlueScope's Technical Bulletin (TB-5): Swarf staining as published on our [website](#).

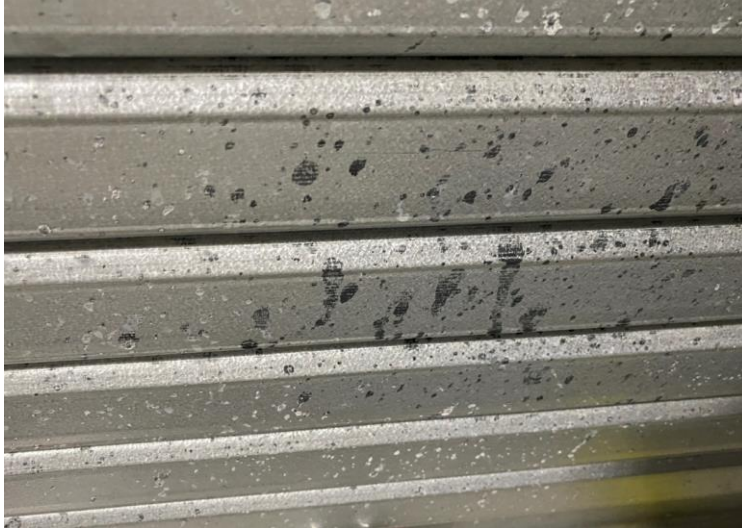
## 2. Chemical damage

General detergent like the household detergent is normally harmless when used in conjunction with BlueScope's coated steel products. There are countless types of chemicals used for different purposes, such as their usage as a cleaning solution. However, if you intend to use a specific chemical for a specific purpose, please confirm with the chemical provider that it will not attack the elements (zinc, aluminium, or steel) and that it is suitable to be used.

It is a good practice to establish a regular routine for washing exterior of BlueScope's coated steel products, which you may refer to BlueScope's Technical Bulletin (TB-4): Maintenance of Exterior BlueScope Coated Steel Products published on our [website](#). If you observed splash marks such as the above photo and they cannot be removed by wiping, chances are there has been a splash of concentrated chemicals that is reactive to the surface. To rectify the damage, you may consider concealing the splash marks by applying a layer of paint, which you may refer to BlueScope's Technical Bulletin (TB-2): Overpainting and restoration of exterior BlueScope coated steel products as published on our [website](#).

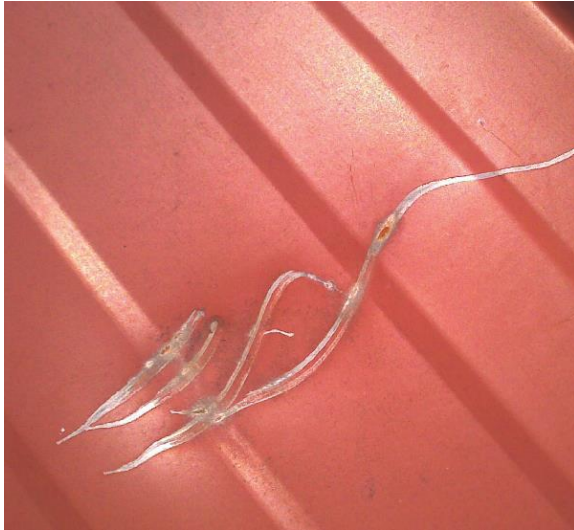
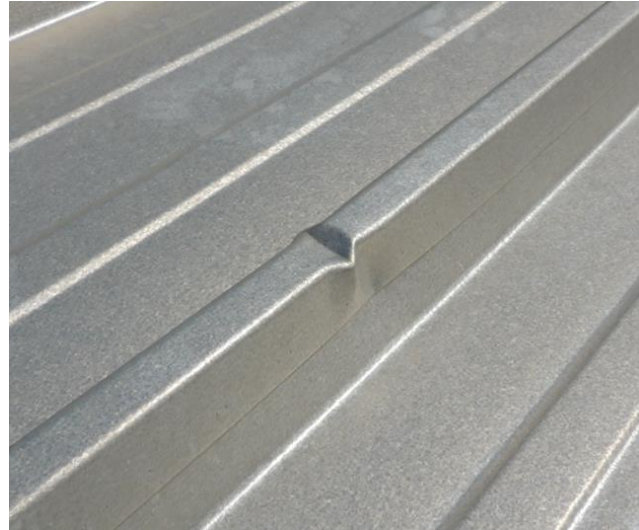
### 3. Mechanical damage

You should not see a scratched or dented roofing sheet upon its arrival at your site, because it would have been rejected during the manufacturing process. Regardless, if you still observe mechanical damages on the end-product when it is installed onto the building, then you may reach out to your installer.

To determine what method to rectify surface scratches, you may refer to BlueScope's Technical Bulletin (TB-2): Overpainting and restoration of exterior BlueScope coated steel products as published on our [website](#). But if the mechanical damage has perforated the roofing sheet, we recommend a replacement.

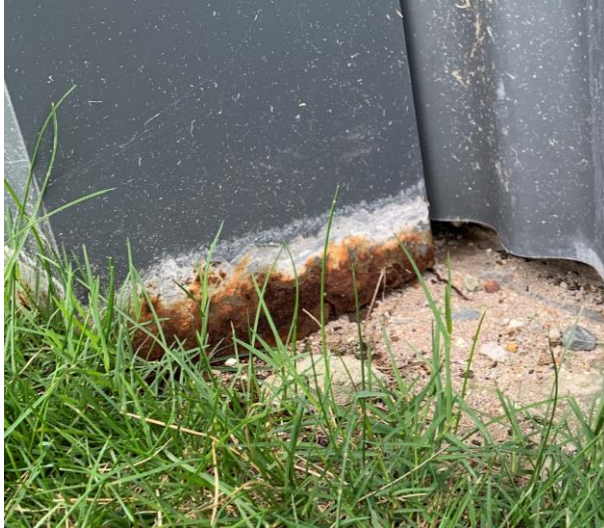
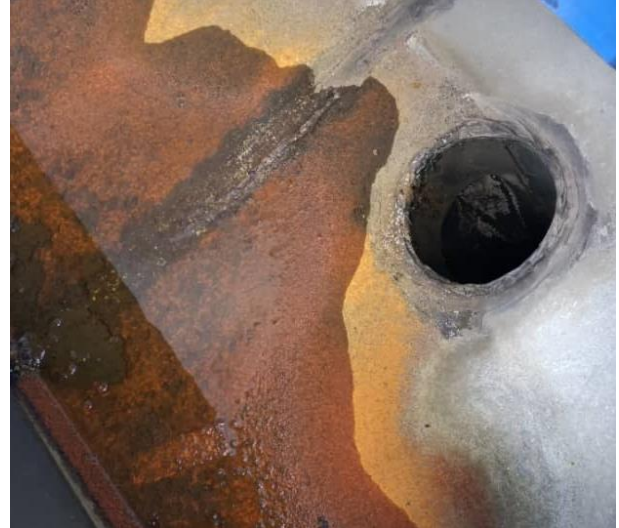
#### 4. Failure to provide free water drainage

Stagnant water can mean water that is retained by medium such as concrete or soil, and it can also mean literal stagnant water due to pooling effect. Either way, coated steel will not perform desirably when it is subjected to stagnant water, as shown in the above photos. Typically, we would refer to the coated steel as being in an “immersion” state, where it is immersed in water.

This problem can only be rectified if the component is replaced, and a change of design/installation approach is employed to actively avoid stagnant water. For more information about immersion, please refer to BlueScope’s Technical Bulletin (CTB-16): Immersion as published on our [website](#).

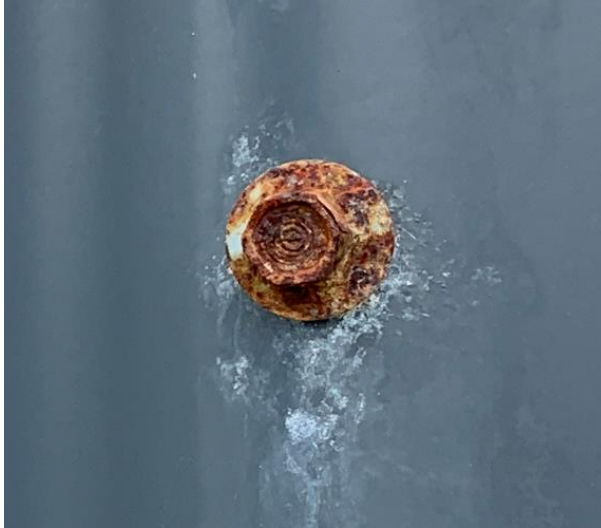
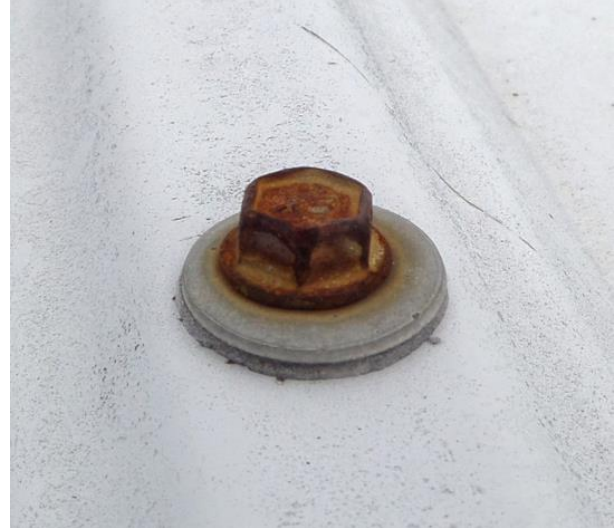
## 5. Contact with corroded fasteners

Fastener is one of the most crucial components to hold down your roofing sheets, where failure of fastener in term of corrosion could lead to roofing detachment. Therefore, choosing of fastener is equally as important as choosing your roofing sheets! We have seen fasteners rusting and spreading the rust onto the roofing sheets.

To determine the selection of fastener in terms of longevity, you may refer to BlueScope's Technical Bulletin (TB-16): Fasteners for roofing, walling and accessory production – selection guide as published on our [website](#). In case you see rusted fasteners, we recommend you reach out to your installer to replace them.

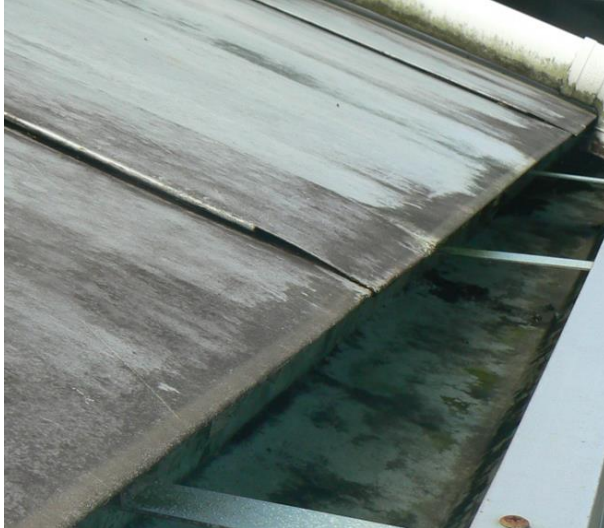
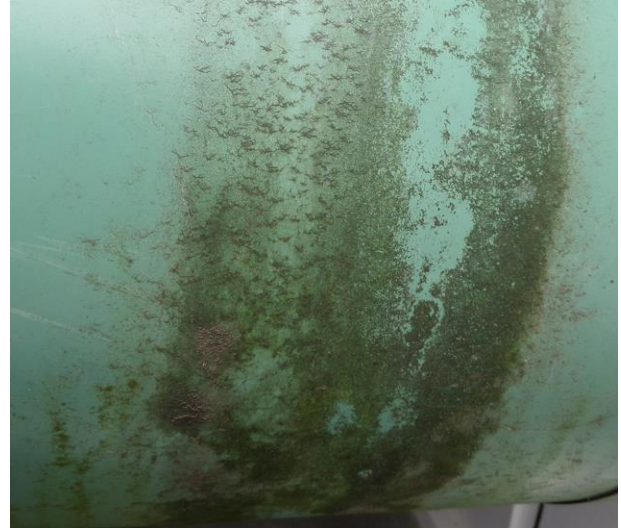
## 6. Fungus stains

The growth of fungus on the exterior building surface is common in tropical region, especially in environment that is humid and cooling.

There is yet any known solution to prevent the growth of fungus on the roofing sheets, however you may refer to BlueScope's Technical Bulletin (TB-27): Identification of fungus in the field and recommendations for its removal as published on our [website](#) for the recommended method to remove the fungus.
